PROBLEMS WITH THE COMBO C2 VERSION PCB'S

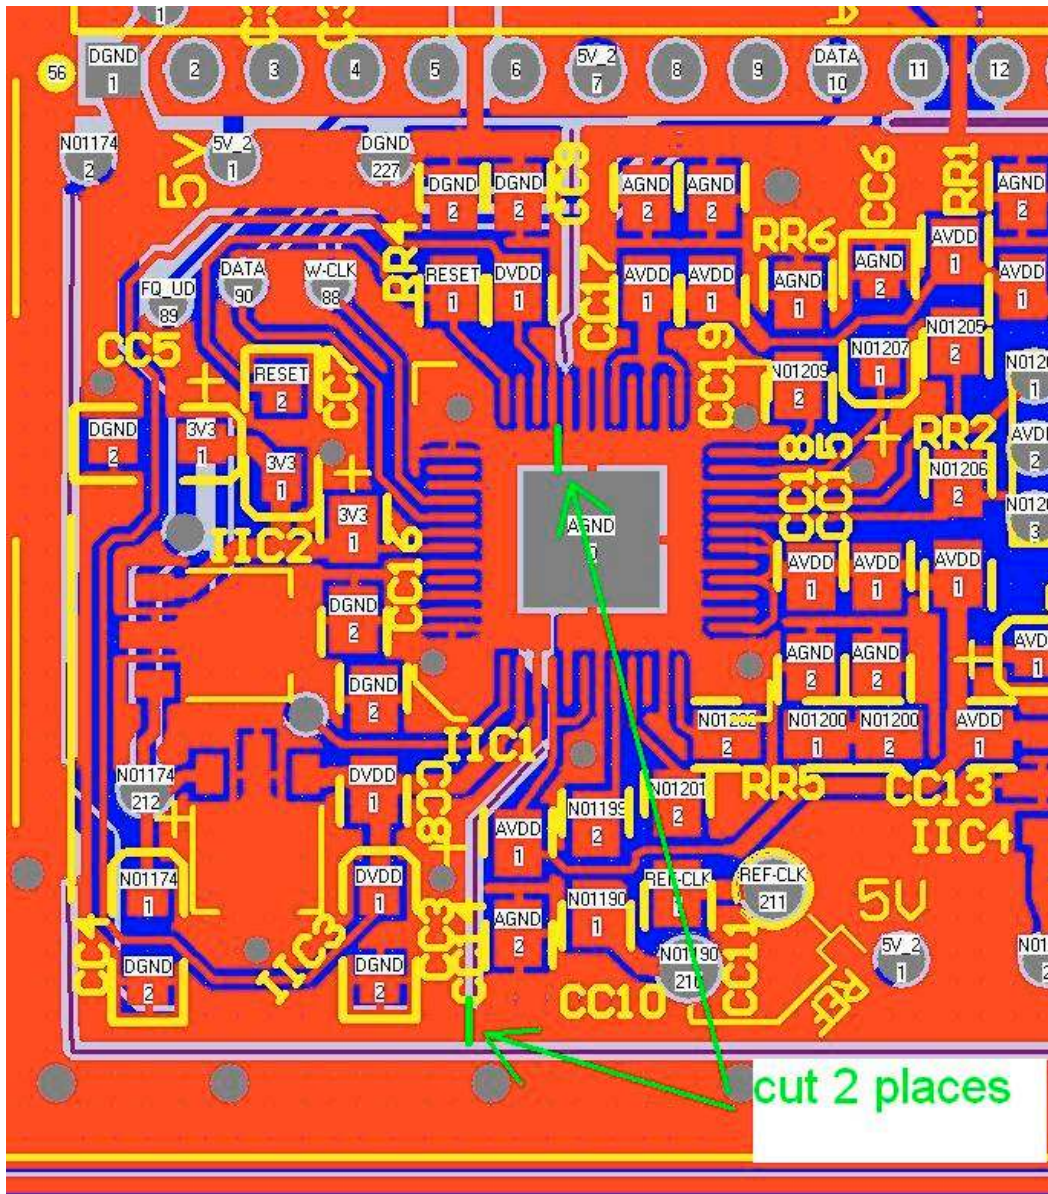
While this actually is unlikely to cause any real problem, without any measurements being taken of the DDS output, the grounds on the DDS area have been accidentally joined when the ground areas were poured. The PCB package shows no errors but they are joined! The bottom is OK.

Use a sharp knife to carefully cut the two sections of track shown below on the TOP of the PCB only, in the DDS area. Ensure the area under the DDS chip is smooth after cutting.
