TrxAVR-Picastar by G3VPX.

These pages are by VK3PE for construction of the TrxAVRB I/F PCB's.

Errors on the PCB:-

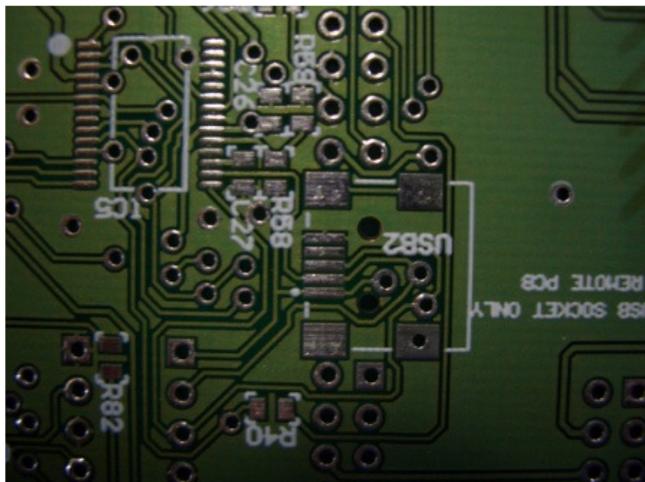
Bottom of PCB.

There is an error on the central "USB2" connector. This probably won't be a problem to most builders. There is no ground connected to the top pin. (the very centre of picture, just to right of "R58") This USB connector though is ONLY used if the central section of the PCB is removed, as per the information above. There is a ground hole just to the left side of C27 so a short near horizontal wire could be fitted. Normally, the other USB connector further to the right will be used, or a remote USB socket.

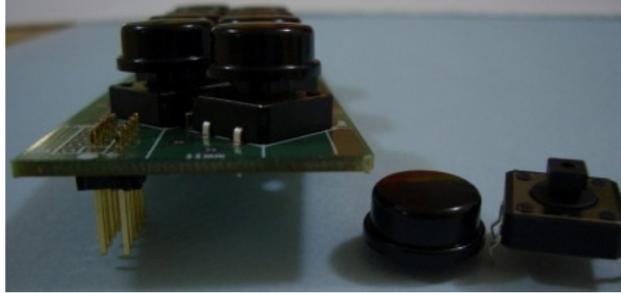
The 8 button keypad (right hand small PCB on panel)

The holes for the 10 way IDC connector have been drilled 2mils (2 thousands of an inch) undersize. This does not sound like much but the connector will NOT go in. The best way to solve this problem is to use a sharp knife and scrape two corners of each pin of the connector a little, until it can be comfortably inserted into the PCB. Do NOT drill the PCB holes out as they are plated through holes and you will lose connectivity.

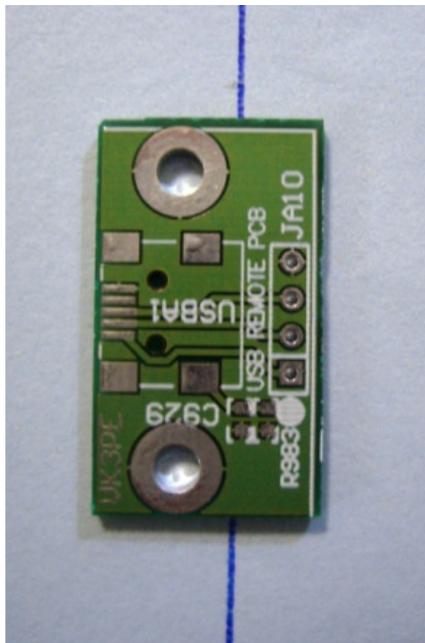
Remote USB board (top left PCB on panel)

MAJOR PROBLEM WITH THIS PCB ! My sincere apologies for this error. Red face department ! The USB connector is reversed on the PCB ! There is no simple way to correct this I am afraid. The PCB may not be needed though, depending upon how you build the interface but there is a "fiddly" way to use it. Carefully cut off the right hand section (see line below) and mount the connector. Then, solder wires to the pads of the connector. This won't be all that easy though, I am afraid.
